## AKD™ Firmware Release Notes

**Firmware Version: M\_01-02-00-000**

This document describes the changes between the previous firmware release (M\_01-01-00-001) and the current release (M\_01-02-00-000). The firmware files in the current release are described in the table below and are available on the Kollmorgen web site:

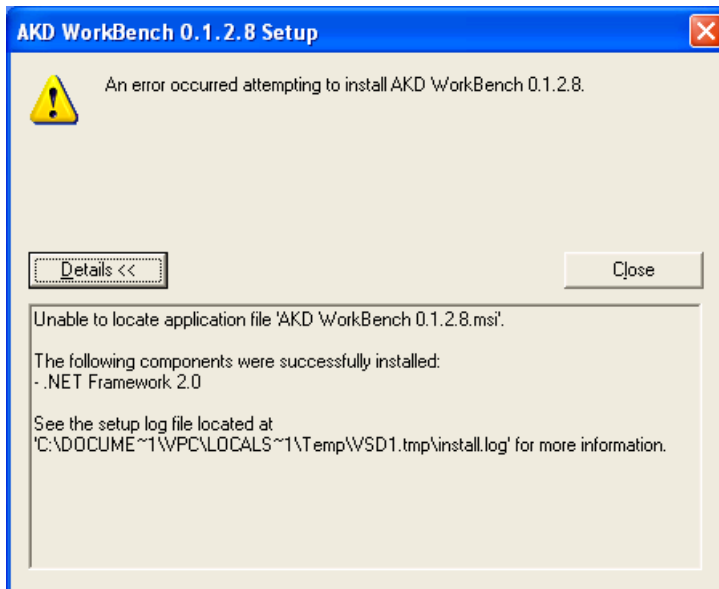
installs .NET 2.0, which requires Windows Installer 3.0 or later. If your computer does not have Windows Installer 3.0 or later installed, then .NET 2.0 is downloaded and installed during the installation process, but you must then reboot in order to install WorkBench. After rebooting, you may see the following popup message:

This error occurs because the temporary installation files were removed after rebooting. You must rerun the AKD WorkBench setup utility to complete the installation.
